Fall from Height

Issue No.	SB39
Issue Date	14 April 2015
Issuer	IRATA Health & Safety Committee
Status	Report following operating members' reports

IRATA SAFETY BULLETIN SB39 Fall from Height

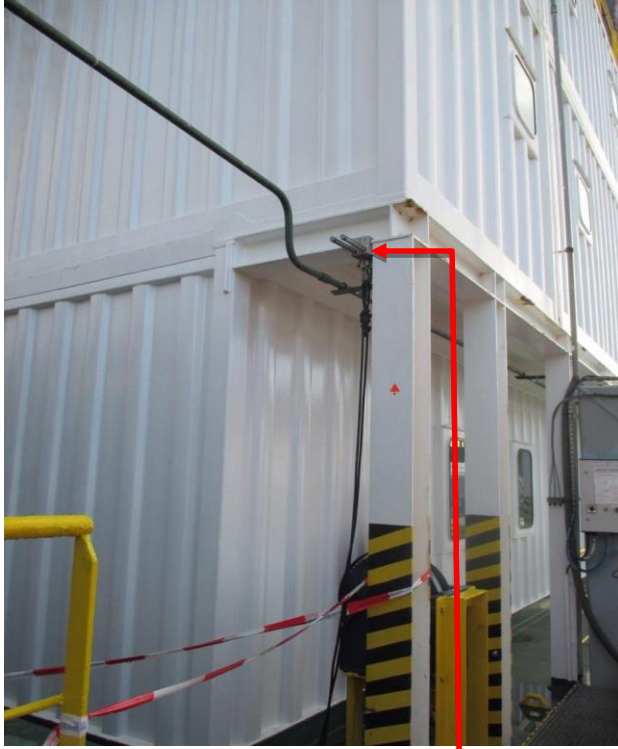
Tech 3 was secured with ropes from the rigging attached to beam clamps (see Figure 3, point A and Figure 4, point D).

Figure 3 - Point A rigging

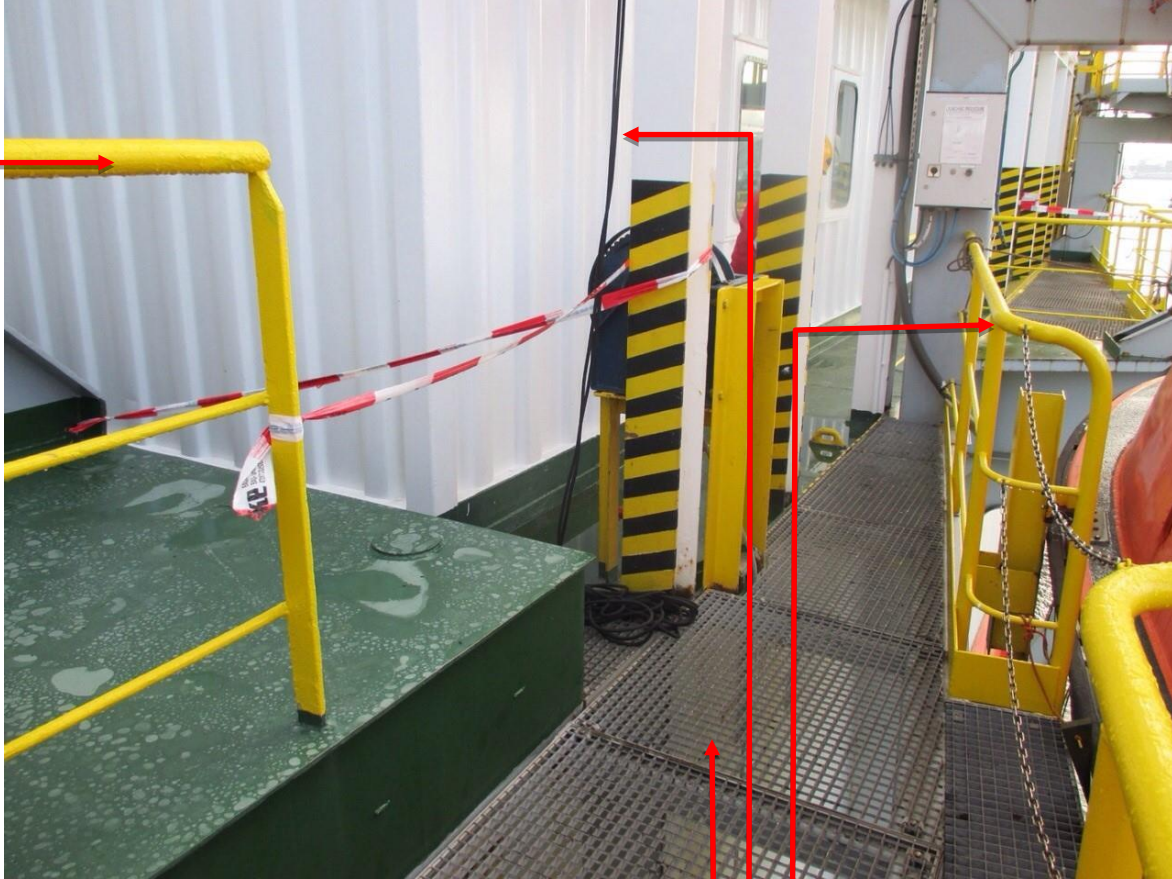
Figure 4 -:

The rope access supervisor (Tech 2) for the task was preparing the rigging with beam clamps in order to inspect the next welding spot. To gain proper access to the welding spot and to properly perform a rescue if necessary, walkway grating (see Figure 4, point B) was removed by Tech 2 and Tech 3 and placed out of the way.

During this action, Tech 2 had secured himself with a lanyard to the top of the handrail (see Figure 4, point C).

Tech 2 noticed that Tech 1 had his leg near the lifeboat control panel. His intention was to warn Tech 1 to be aware of the control panel. In order to warn Tech 1, Tech 2 turned himself 90 degrees to the right in order to face Tech 1. Now Tech 2 is facing the hole in the grating. At the same time Tech 2 intended to take a different position on the grating, in the direction of Tech 1. Taking a different position, Tech 2, removed with his left hand lanyard from point C (see Figure 4), made a step with his left foot and intended to secure himself to point E (see Figure 4) with the lanyard in his right hand.

While doing these multiple maneuvers, for a split second Tech 2 was unsecured and stepped into the hole of the grating. As a result, Tech 2 fell through the opening in the walkway grating and into the water from 14 meters high. Tech 2 fell with his feet downwards into the water. When coming back to the surface the lifejacket started to inflate.

- Point B= Tech 2 & 3 removed grating panel
- Point C= Tech 2 secured with lanyard
- Point D= Tech 3 secured with ropes to harness
- Point E= Tech 2 intended to attach to new point with right hand

will adjust the RA-OPS (Rope Access procedure) with an additional paragraph explaining the procedure what to do with unstable or open surfaces and/or grating. In detail will be explained that in case of open surfaces, lifelines / safety-lines will be placed along the open surfaces. Lifeline / safety-line will be fastened to proper anchor points. In case a lifeline / safety-line will be in place, the necessity for unhooking yourself when changing of position in case necessary, is limited.
